## UAV and GIS based rapid earthquake-induced building damage assessment and methodology for EMS-98 isoseismal map drawing: The June 12, 2017 Mw 6.3 Lesvos (Northeastern Aegean, Greece) earthquake

On June 12, 2017, an Mw 6.3 earthquake struck Lesvos Island (Northeastern Aegean, Greece). Building damage was observed in its southeastern part with very heavy structural damage limited in the settlement of Vrissa. Taking into account that Vrissa is located further inland from the epicenter than other settlements with less damage, Vrissa looks like an earthquake impact paradox. For interpreting this paradox, a complete approach for damage assessment in an earthquake-affected area was applied during the first hours of the emergency response phase in order to provide crucial information to civil protection agencies. It comprises integration of building-bybuilding inspection, use of desktop and web GIS applications, UAV survey and digital post processing, extraction of data and information related to the buildings of the affected area, application of the European Macroseismic Scale 1998 and assignment of macroseismic intensities. Correlation of the all aforementioned data with the geologic

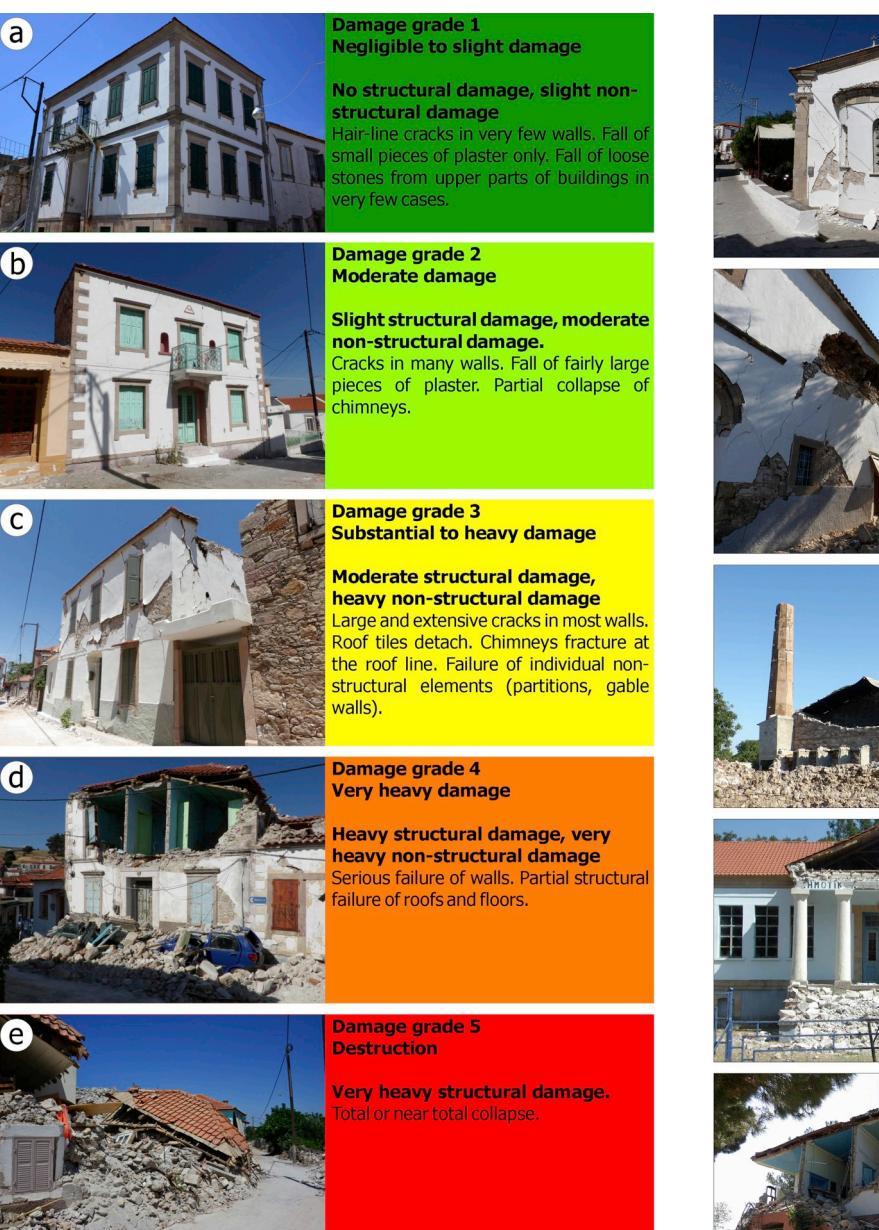
**Fig. 9.** Masonry buildings suffered the most by the 2017 Lesvos earthquake. The observed damage grades varied from 1 (a) to 5 (e). The classification of damage to masonry buildings is based on the EMS-98.

The masonry buildings suffered the most by the 2017 Lesvos earthquake. They sustained (a) damage grade 1 (negligible to slight

damage) comprising hairline cracks in the load-bearing masonry walls (Fig. 9a), (b) damage grade 2 (moderate damage) including cracks in many walls, detachment of small pieces of places from the walls and partial collapse of chimneys (Fig. 9b), (c) damage grade 3 (substantial to heavy damage) comprising large and extensive cracking of all masonry load-bearing walls, detachment of large pieces of plaster in all load-bearing walls, dislocation and fall of roof tiles, detachment of the

roof from the rest of the structure and fall of gables (Fig. 9c), (d) damage grade 4 (very heavy damage) including heavy structural failure of roofs and floors (Fig. 9d) and (e) damage grade 5 of partial and total collapse (Fig. 9e).

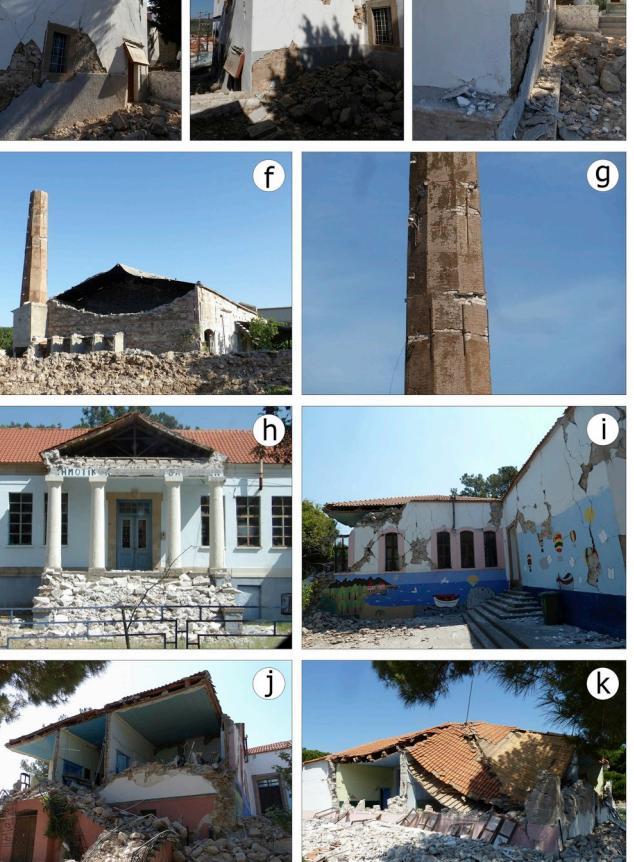
**Fig. 10.** Special structures including churches, industrial buildings and their masonry chimneys as well as schools suffered heavy damage from the 2017 Lesvos earthquake. Churches suffered damage including large cracks in various parts such as walls (a–e) and the dome, detachment of large pieces of plaster from load-bearing masonry walls (a, b, c, e), dislocation and fall of several roof tiles (e) and partial collapse of load-bearing masonry walls (c, d, e). Masonry industrial buildings in Vrissa suffered large cracks and partial collapse of their masonry walls (f) and large cracks of their masonry chimneys on the verge of collapse (g). School buildings suffered damage varying from fall of the gable over the main entrance (h) and cracks in their masonry walls (i, j) to partial collapse (k).

The special structures including temples, post-byzantine structures, museums, schools and industrial buildings with masonry load-bearing walls suffered similar damage with the masonry residential buildings. More specifically, temples suffered damage comprising cracks in most of the masonry walls (Fig. 10a and b) and in other parts such the dome, the columns, the aisles, the apse and the gable. Post-byzantine structures suffered the aforementioned damage as well as partial collapse of the walls (Fig. 10c–e).

Industrial buildings suffered partial collapse of the perimeter masonry walls and damage of the masonry chimneys on the verge of collapse (Fig. 10f and g). A typical example is the industrial building located at the northern entrance of Vrissa settlement comprising an oilmill along with its masonry chimney (Fig. 10f and g). The main building is composed of masonry load-bearing walls built with roughly treated stones and handmade solid clay bricks, while the masonry chimney has been built with solid clay bricks (Fig. 10f and g). Unfortunately, both structures were abandoned since the late 90s, but they were typical examples and reminders of the industrial prosperity of Vrissa during the late 19th century. Schools suffered fall of the gable above the entrance and partial collapse of the load-bearing masonry walls (Fig. 10h-k).

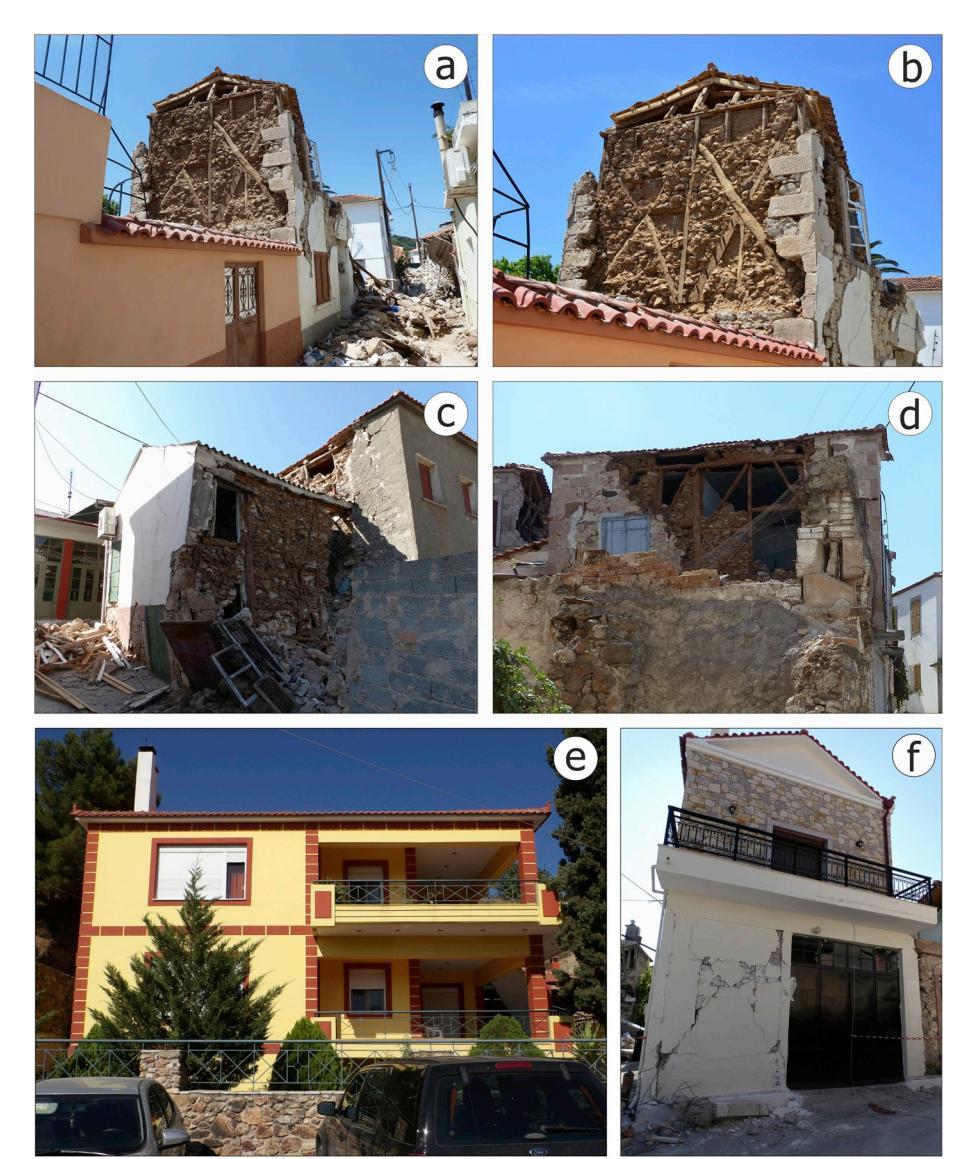
Fig. 11. (a-d) Traditional residential buildings with dual structural system including masonry walls and timber frames with extensive "X" bracing in Vrissa settlement (a-d). During an earthquake, these frames could guarantee the stability of the roof in case of a partial collapse of the masonry structure. This dual structural system represents one of the earliest surviving architectural responses to earthquake motion in Greece and Turkey and was also observed in Eressos and Bergama by Refs. [64,65]. (e-f) The R/C buildings showed good performance and remained almost intact (e) by the 2017 Lesvos earthquake. But there were exceptions (f) including cracks in the infill walls, detachment of large pieces of plaster from the infill walls of the ground floor as well as detachment of the infill wall from the surrounding RC frame.

As regards traditional buildings with the dual structural system, they performed better than the masonry structures with load-bearing walls. The primary structural system comprising the masonry walls of the ground floor sustained no structural damage and light non-structural damage including cracks of the masonry (Fig. 11a-d). The secondary structural system showed good performance during the earthquake sustaining successfully the vertical loads of the upper floor and resulting in still standing residential buildings after the earthquake, despite the fact that the masonry suffered damage varying from large cracks to partial collapse (Fig. 11a-d).

All R/C buildings constructed during the last decades showed good performance during the 2017 Lesvos earthquake since none of them suffered heavy structural damage. R/C buildings suffered only non-structural damage including cracks in the infill walls, detachment of large pieces of plaster from the infill walls and detachment of the infill walls from the surrounding R/C frame (damage grade varying from 1 to 2 based on the EMS-98) (Fig. 11e and f). However, some free standing elements sensitive to base accelerations were dislocated and damaged.

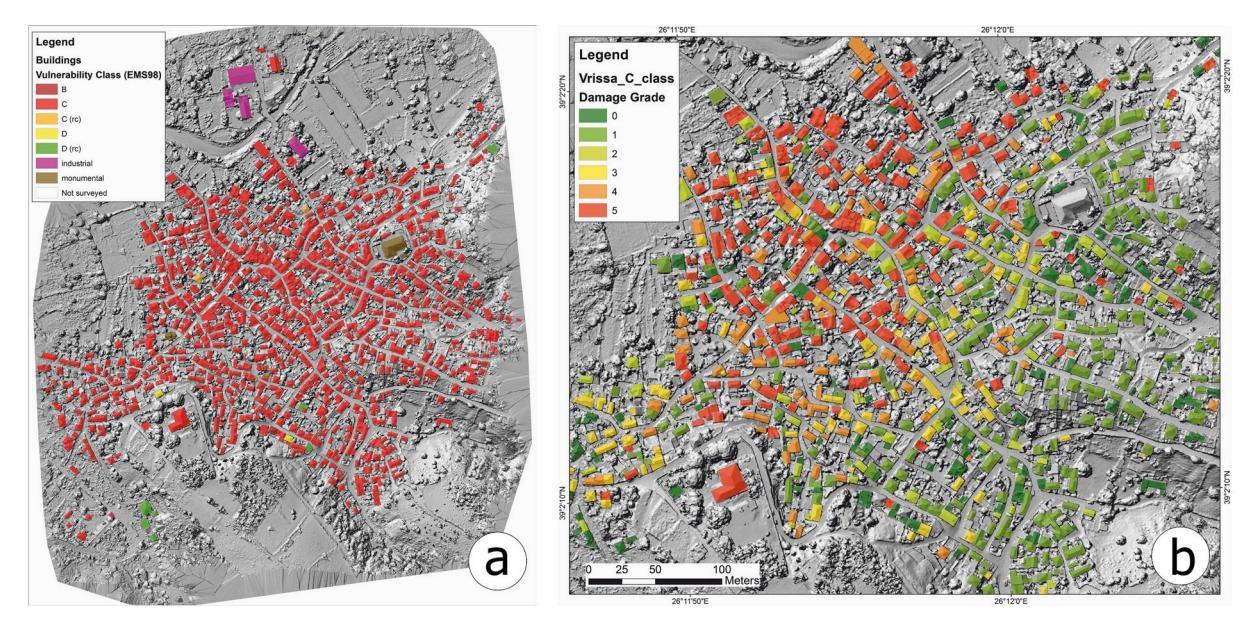
The field observations including vulnerability classes, building damage and damage grades based on the EMS-98 application were verified for accuracy by revisiting the site through the acquired 3D model produced in previous step of the applied methodology and by using all footage available for any point on demand, in Pix4D (Fig. 12). All polygons were finally attributed with a unique number, a code description referring to the building type, a vulnerability class and a damage grade. A vulnerability map (Fig. 13a) and a damage grade map (Fig. 13b) were produced based on the buildings polygon and their attributes.

Fig. 13. (a) Vulnerability class and (b) damage grade maps of Vrissa settlement based on the EMS-98.
