QUANTIFICATION OF HUMAN IMPACT ON NATURAL EVOLUTION PROCESSES AT A COASTAL ZONE, ADJACENT TO AN ACTIVE FAULT

EXTENDED ABSTRACT

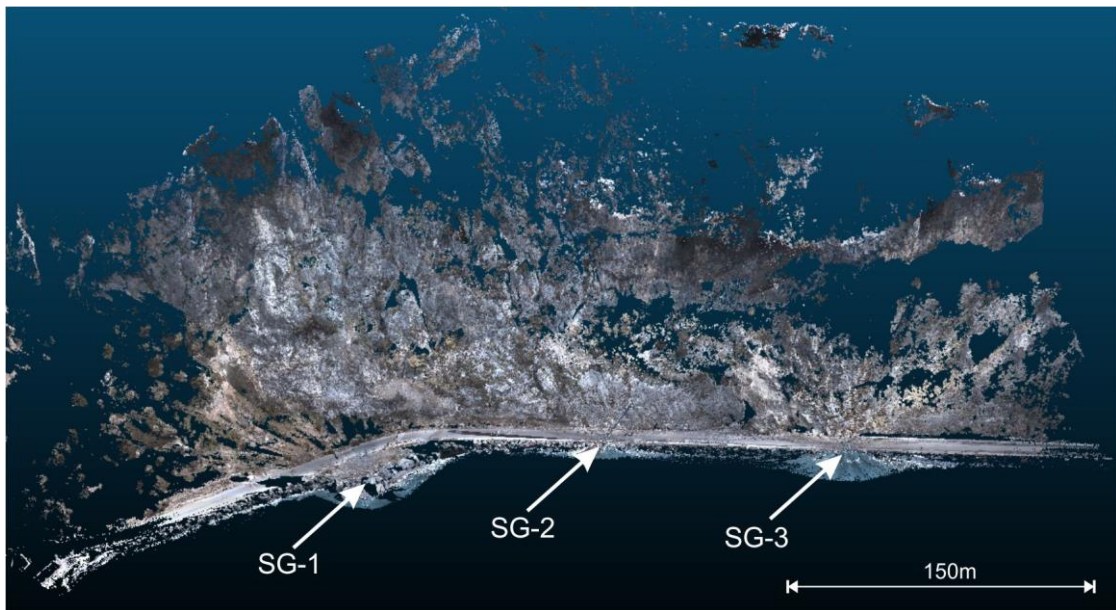
Figure 2. Locations of the local control network stations on a true color 3-D view produced by the point cloud acquired from the ground-based laser scanning.

The SG-1 station was placed on a large limestone block which was naturally fallen on the beach area, in order to have good visibility at the debris outcrop, whilst the next two (SG-2 and SG-3) were placed on the sidewalk along the road next to the coastline. The latter were placed opposite from the vertical cliffs, which have been formed by the fault activity, in order to acquire the largest possible relief information of the fault surface during the laser scanning (Abellan *et al.*, 2006, Buckley *et al.*, 2008, Lato *et al.*, 2012). Finally, the surveying methodology was completed by laser scanning of the onshore coastal area. A terrestrial laser scanner was used (Leica ScanStation C-10) and placed on the three established stations (see Figure 3a). Three point clouds with 2-5cm measurement spacing and $\pm 6\text{mm}$ precision were merged in a single point cloud covering the entire coastal area and minimizing the shadow effect due to the roughness of the cliff (Wiatr *et*
