## On the Lefkas (Ionian Sea) November 17, 2015 Mw=6.5 Earthquake Macroseismic Effects

We exploit macroseismic observations and instrumental data aiming at explaining the effects of the 17th November 2015 Mw=6.5 earthquake, occurred beneath the southwestern peninsula of Lefkas Island (Ionian Sea) causing two casualties, major geo-environmental and slight-to-moderate structural effects. The spatial distribution of the structural damage of the local building stock is well correlated with the deformation pattern deduced from satellite geodesy, it appears though considerably low with respect to the ground deformation. Comparison with the previous strong earthquake on 14.8.2003 with Mw=6.2 occurred about 20 km to the north, shows that structural damage was significantly lower during the recent quake and also manifests good behaviour of the local buildings. This is partly explained by the characteristics of the ground motion and primarily explained by the unique concepts applied to the non-engineered buildings of Lefkas to resist ground motions.

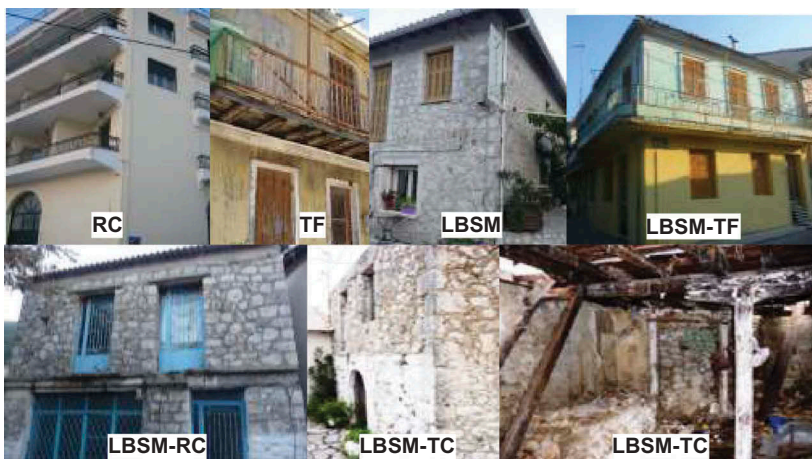
**Figure 4.** Examples of the Lefkas buildings typologies. Photos taken by our group in 2015–2016 and Kalantoni [2016].

This typology is present mainly in the capital of Lefkas Island and the seafront regions (Fig 4), where the local population possessed the craft of the wooden shipbuilding, on which the house construction is assumed to be based [Papadatou-Giannopoulou, 2014]. The timber in use was mainly wild wood (oak, fir, and cypress), thanks to the large dimensions and its enhanced bearing capacities, while flexible olive tree wood or roots were used for the corners. The trunks were immersed into the mud of the lagoon in eastern Lefkas, a controversial technique applied for sealing the wood prior to the application, to protect it from deterioration. Often the wood was also coated with tar. The external sheathing was initially wooden as well but, due to the wet climate, it was later replaced by smooth or corrugated iron plates, which lead to the architectural degeneration of the typology [Papadatou-Giannopoulou, 1999].

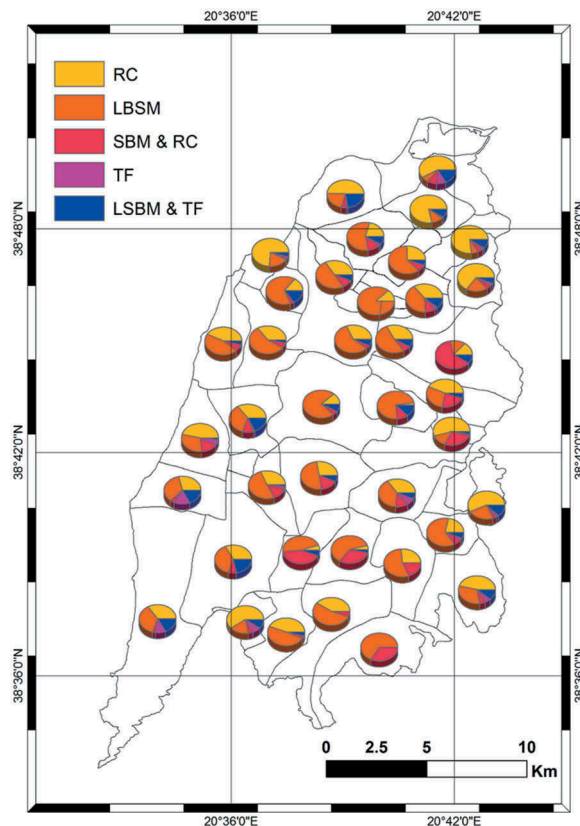
**Figure 5.** Distribution of building typologies across Lefkas [data from Karababa and Pomonis, 2011].

Although 65% of “Yellow” and 88% of “Red” tagged buildings, correspond to the LBSM typology, their seismic response is considered satisfactory, given their multitude across the epicentral area (Fig 5, Fig 10 left). All LBSM buildings variations presented a similar behavior/failure pattern regarding the primary stone masonry load bearing system, i.e. separation of walls at intersections, cracking and tilting of wall panels due to out-of-plane mechanisms, diagonal in-plane cracks initiating from weak areas, delamination of wall wythes loosely interlocked (Fig 14a). Dislocation and fall of roof tiles has been often observed.

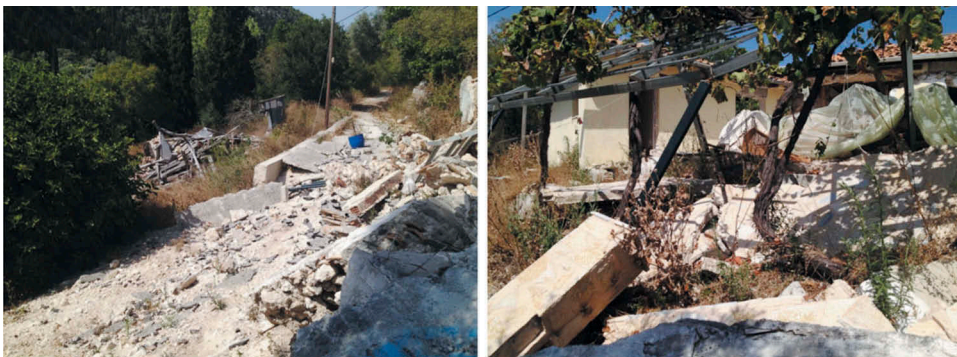
**Figure 8.** Field photographs (July 2016) showing structural damage imposed by an earthquake-induced landslide at Dragano.

Fig 7 shows the spatial distribution of damage at the most affected villages of Komilio, Dragano, Athani and Agios Petros (see Fig 2 for location), in terms of “Green”, “Yellow”, “Red” color coding, after SER. To produce these maps, given the lack of vector data in the area, satellite imagery was employed and processed to acquire the building footprints in the epicentral area. Damage characterization was then placed on the footprints after identifying the locations of buildings in the SER protocols by an additional in-situ survey conducted in April 2016. It is worth noting the case of Dragano where damage related to out-of-plane failure of the bearing walls (Fig 8) reported at the western part of the village (circled in red in Fig 7) is thought to be caused by an earthquake-induced slope failure.

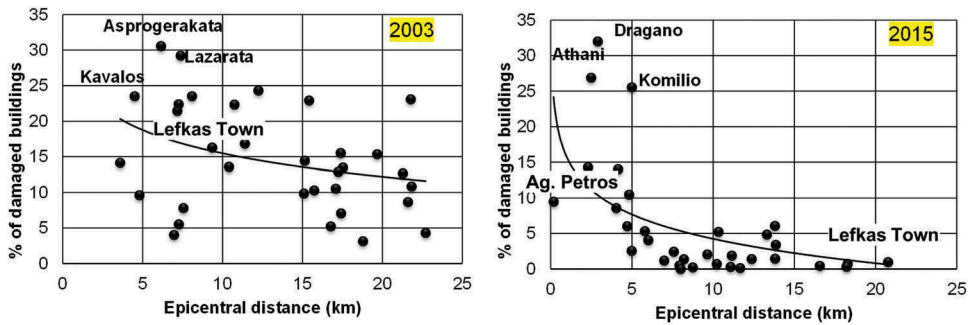
**Figure 11.** Relative number of damaged buildings per total building stock of every checked urban district, with respect to the epicentral distance for the 2003 (left) and the 2015 (right) earthquake. Black solid lines represent polynomial fit to the individual data points that correspond to cumulative observed damage per district (solid circles). Details for the 2003 event can be found in Karababa & Pomonis (2010) and for 2015 event in Table A1 (Appendix A).

[Fig 11](#) presents the reported damage distribution of the 2003 and 2015 earthquake of all building typologies with respect to the epicentral distance. The figures show that damage decays with distance, as expected and this is more explicit in 2015 earthquake. For the case of the 2003 event ([Fig 11a](#)), higher discrepancies are observed, given that damage was distributed in a wider radius, whereas in 2015, the relative damage per district’s building stock decays significantly within a small epicentral distance ([Fig 11b](#)). When comparing with the total damage throughout the island, the 14% of the total building stock have been characterized as unsafe or dangerous due to the 2003 earthquake versus 3% due to the 2015 one. The larger amount of total damage during the 2003 earthquake can be first explained by the fact that structural damage was registered at some level almost

throughout the entire island (Fig 11, Fig 16), but also by the fact that the event affected the densely populated northern part of the island (incl. the capital town) with a much more important exposed building stock. The damage configuration of the two earthquakes can be explained by the rupture kinematics of the two earthquakes: during the 2003 event, rupture initiated in the north and propagated to the south reaching the northern coast of Cephalonia Island [Benetatos *et al.*, 2007], thus affecting the whole Lefkas island; during the 2015 earthquake, the maximum slip was concentrated south of the epicenter [Melgar *et al.*, 2017], affecting mainly the southern part of the island, which is sparsely inhabited.

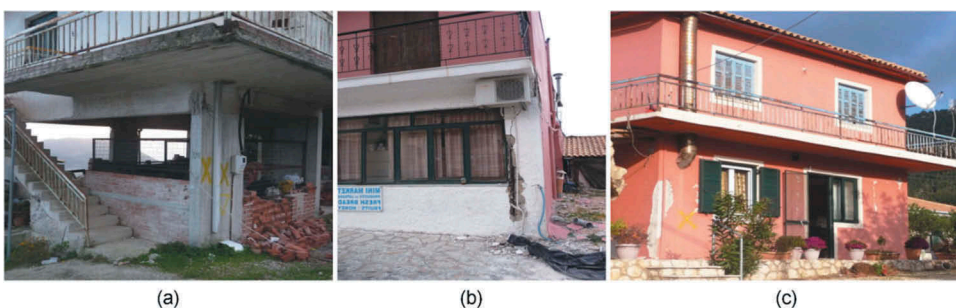
**Figure 12.** Damaged RC buildings in Athani: (a-b) Damage to columns and beam column joints at RC buildings; (c) Large cracks at infill panels.

The structural damage described in SER documents for "Yellow" buildings and observed on site were cracks in RC elements (beams, columns, joints) at different extent, spalling of concrete cover and buckling of rebars for some limited cases (Fig 12a, b). The most common failure is related to delamination and diagonal cracking of the infill panels (Fig 12c). In several cases, buildings have been characterized "Yellow" due to local soil instability and foundations compliance. Hairline cracks at infill walls or at the plaster of structural elements and limited dislocation of tiles led to "Green" characterization. Non-structural damage, such as cracks in partition walls, fall of brittle cladding and mortar (Fig 13c), account for Grade 2 (moderate damage) and "Unsafe for use" characterization.

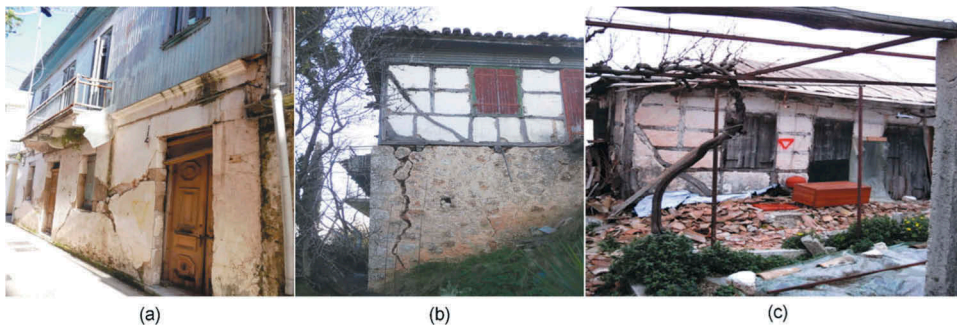
**Figure 13.** The crack pattern surveyed for the traditional LBSM-TF typology: (a) An abandoned house in Lefkas town with in-plane diagonal shear cracking; (b) Building in Agios Petros with wall angle detachment due to ground subsidence; (c) “Red” tagged building in Athani with timber frame vertical deviation.

**Figure 13.** (Continued).

Other source of damage was the static ground deformation, which has not been possible to be assimilated by separate footings, especially of the older buildings. As far as the response of RC buildings located at larger epicentral distances is concerned, failures were mostly generated by earthquake secondary effects, such as landslide and slope failure, ground subsidence and mutual pounding between adjacent buildings due to insufficient or lack of seismic joints (Fig 13a,b).

Several “Yellow” tagged structures of this typology have been registered, mainly at the epicentral area. Only nine LBSM-TF buildings have been characterized as “Red”, having suffered vertical deviation of the timber framework and extensive cracking of the shear stone masonry walls. Damage registration performed for several cases at various locations showed different structural behavior. This may be due to the state of preservation and the characteristics of the structural components, depending on the period of construction. Damage was mainly concentrated at the stiff ground floor by diagonal shear cracks initiating at the openings (doors, windows) (Fig 13a), whereas the infill material of the upper timber frame structure was cracked and at times dismantled. Interestingly, non-linear dynamic analysis of a LBSM-TF structure indicates high tensile stresses concentrated specifically at these failed zones [Karakostas *et al.*, 2005].

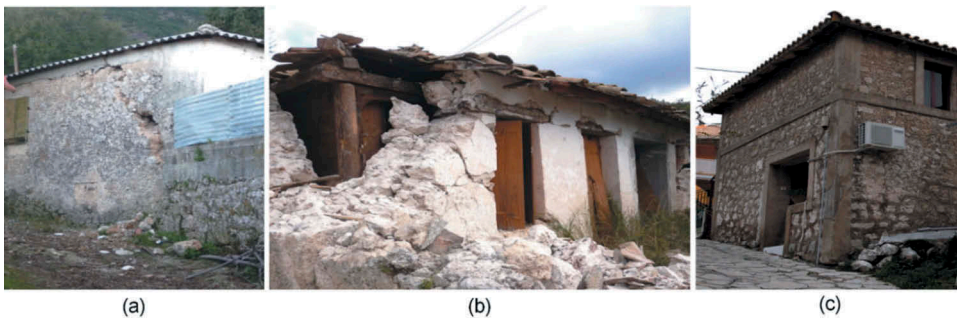
**Figure 14.** (a) LBSM “Yellow” tagged building in Agios Petros; (b) Damage of a single floor LBSM-TC in Athani; (c) LBSM-RC in Kalamitsi remained intact after the earthquake.

The *pontelo* secondary timber load-bearing system of the LBSM-TC buildings, partially discharged the bearing walls and prevented the push over of the masonry walls imposed by the roof rafters. However, the frequent absence of roof anchorage with the perimeter walls increased their susceptibility to toppling. In many cases, the internal wooden columns and beams have been proven to remain intact when the perimeter walls have failed (Fig 14b, Fig 15a). Well preserved LMSB-RC buildings (Fig 14c) exhibited a satisfactory behavior.

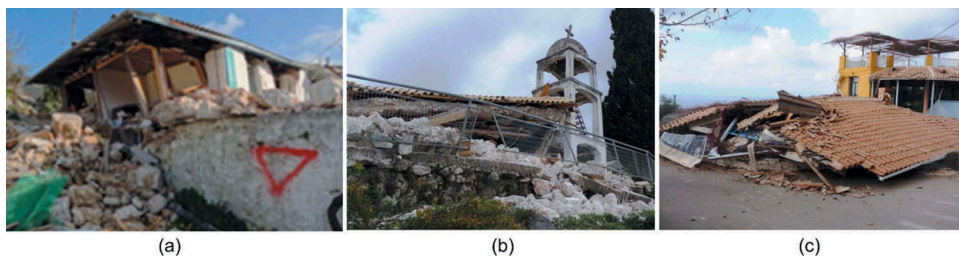
**Figure 15.** (a) Red tagged LBSM-TC building in Dragano with successful performance of TC frame (b) Collapsed Agia Paraskevi church in Athani; (c) Collapsed kiosk near Athani.

A negative case is the Agia Paraskevi church in Athani (Fig 15b): the RC ring beam-roof joist applied during rehabilitation and strengthening works has been proven to pose fatal burden on the stone bearing walls and the old deteriorated *pontelo*, which thereafter was not able to resist to roof gravity loads during the ground shaking. As a consequence, the monument of the eighteenth century collapsed, contrary to the LBSM-TC house of Fig 14b, where the timber frame managed to successfully bear the roof loading despite the failure of its external walls. The undesirable result of Agia Paraskevi church implies that erroneous

interventions and use of improper materials may impose increased risks, cancelling the effective seismic performance of the traditional architecture.
