## **Vulnerability assessment in Lefkada old town (W. Greece) with the use of EMS-98; comparison with the 14-8-2003, Mw=6.2, earthquake effects. First results.**

**Abstract.** The purpose of this paper is to assess the vulnerability to ground shaking of the building stock in the old town of Lefkada Island (Ionian Sea, W. Greece). The study area lies in the most seismically active zone of Greece region. Most of its buildings were built with local practices and have been designated by the European Council Cultural Heritage Unit as representative earthquake resistant constructions. Within the context of this research we conducted an in-situ survey, of all buildings in the old town. In addition, the 2001 buildings census catalogue elaborated by the National Statistical Service of Greece was employed, as well as the damage inspection data following the 2003 earthquake. The collected data, after a detailed processing, were projected as they would have been prior to the August, 14, 2003, Mw=6.2 Lefkada earthquake. Each building was indexed by an EMS-98 vulnerability class. All results were combined in an ArcGIS scheme in order to compute the lateral vulnerability distribution and to comp

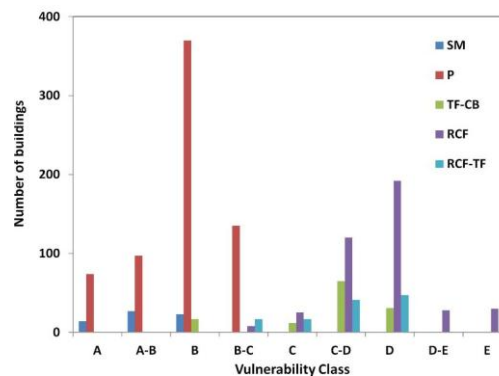
**Figure 4.** Distribution of the old Lefkada town building stock to EMS-98 vulnerability classes with respect to the buildings types (2012) (see text and Table 1).

The scheme proposed by EMS-98 was adopted in order to assign each individual building to a vulnerability class. Apart from vulnerability classes A to E, interim classes (A-B, B-C and so on) were also used based on the structural irregularity and state of maintenance criteria as described in Table 1. Figure 4 presents the resulting distribution of vulnerability classes per type of structures. Figure 5 presents the spatial distribution of the proposed vulnerability classes across the study area. Those, concern the 2012 buildings inventory. All processed data during this phase were incorporated in an ArcGIS building-per-building scheme (Figure 6).

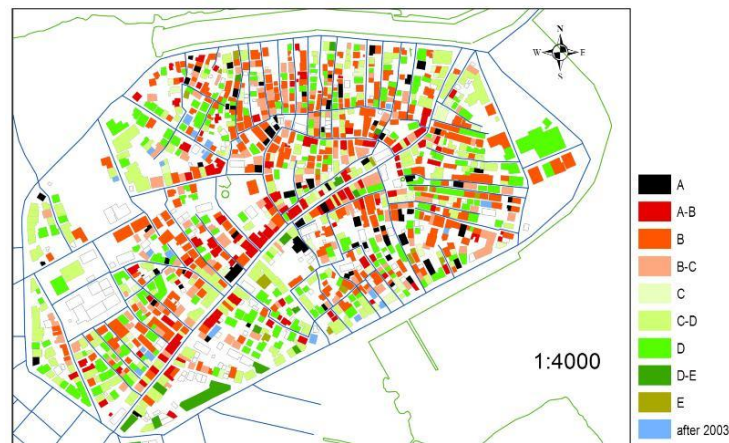
**Figure 5.** Map of spatial distribution of the proposed vulnerability classes (2012). Buildings erected after 2003 earthquake are also shown.

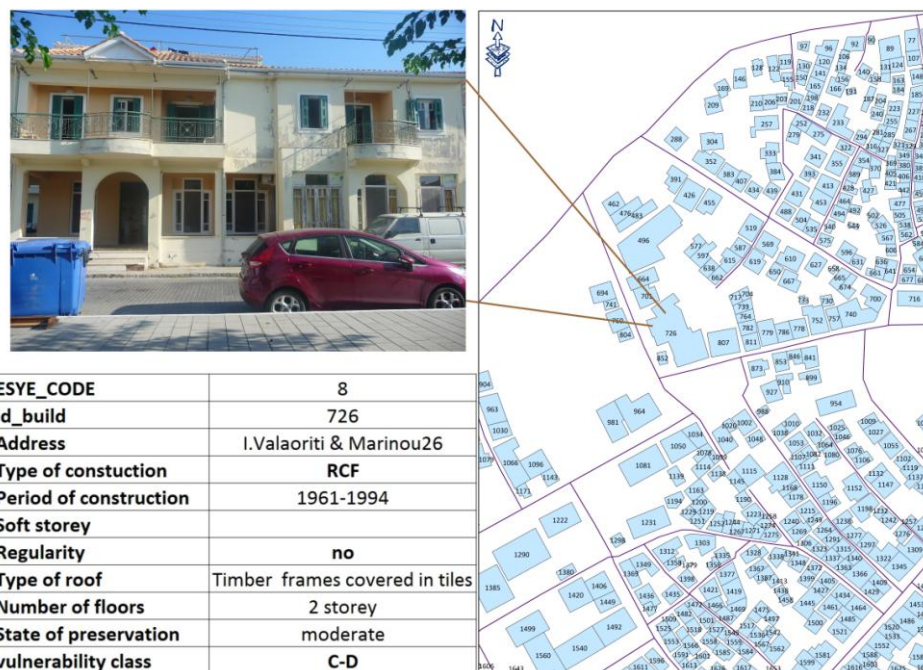
**Figure 6.** Screenshot example of the integrated GIS scheme including ~1500 constructions in old Lefkada town.
