## UAV and GIS based rapid earthquake-induced building damage assessment and methodology for EMS-98 isoseismal map drawing: The June 12, 2017 Mw 6.3 Lesvos (Northeastern Aegean, Greece) earthquake

On June 12, 2017, an Mw 6.3 earthquake struck Lesvos Island (Northeastern Aegean, Greece). Building damage was observed in its southeastern part with very heavy structural damage limited in the settlement of Vrissa. Taking into account that Vrissa is located further inland from the epicenter than other settlements with less damage, Vrissa looks like an earthquake impact paradox. For interpreting this paradox, a complete approach for damage assessment in an earthquake-affected area was applied during the first hours of the emergency response phase in order to provide crucial information to civil protection agencies. It comprises integration of building-bybuilding inspection, use of desktop and web GIS applications, UAV survey and digital post processing, extraction of data and information related to the buildings of the affected area, application of the European Macroseismic Scale 1998 and assignment of macroseismic intensities. Correlation of the all aforementioned data with the geologic

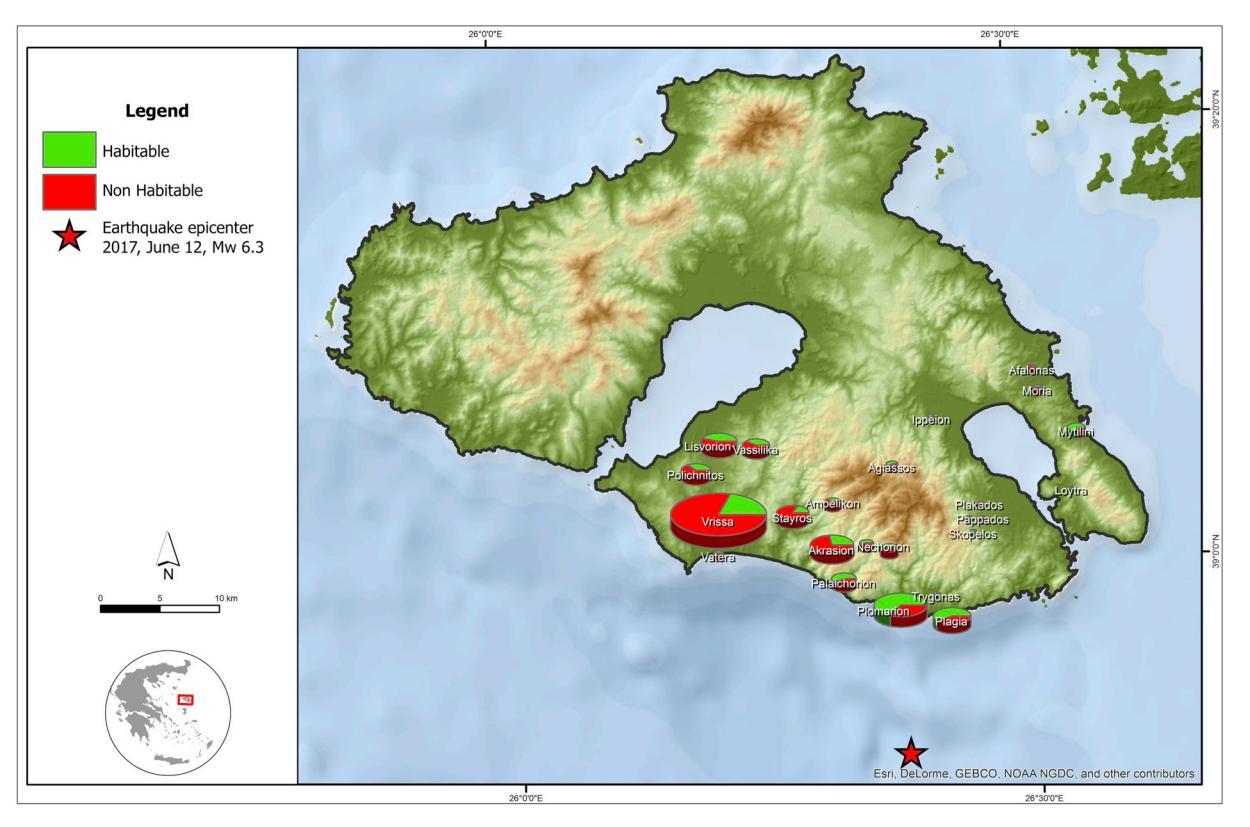
Fig. 3. Percentage of damage per settlement of the southeastern part of Lesvos. Vrissa, Plomari, Akrassi, Plagia, Lisvori, Stavros and Polichnitos are the most affected villages of the affected area. Especially, the traditional settlement of Vrissa was devastated by the earthquake and concentrated the 50% of the non-habitable buildings inspected by the [49].

According to data provided by the [49]; 1115 buildings in 29 settlements of the southeastern part of Lesvos (Fig. 3) were characterized as non-habitable including 976 residential buildings, 41 business premises, 39 temples and public buildings as well as 59 warehouses. More specifically, in Vrissa, 113 buildings were characterized as habitable, while 472 structures including 408 residential buildings, 25 business premises, 6 temples and public buildings as well as 33 warehouses were characterized as non-habitable. Based on the aforementioned data, it is concluded that almost 50% of buildings that suffered damage are concentrated in Vrissa settlement (Fig. 3).

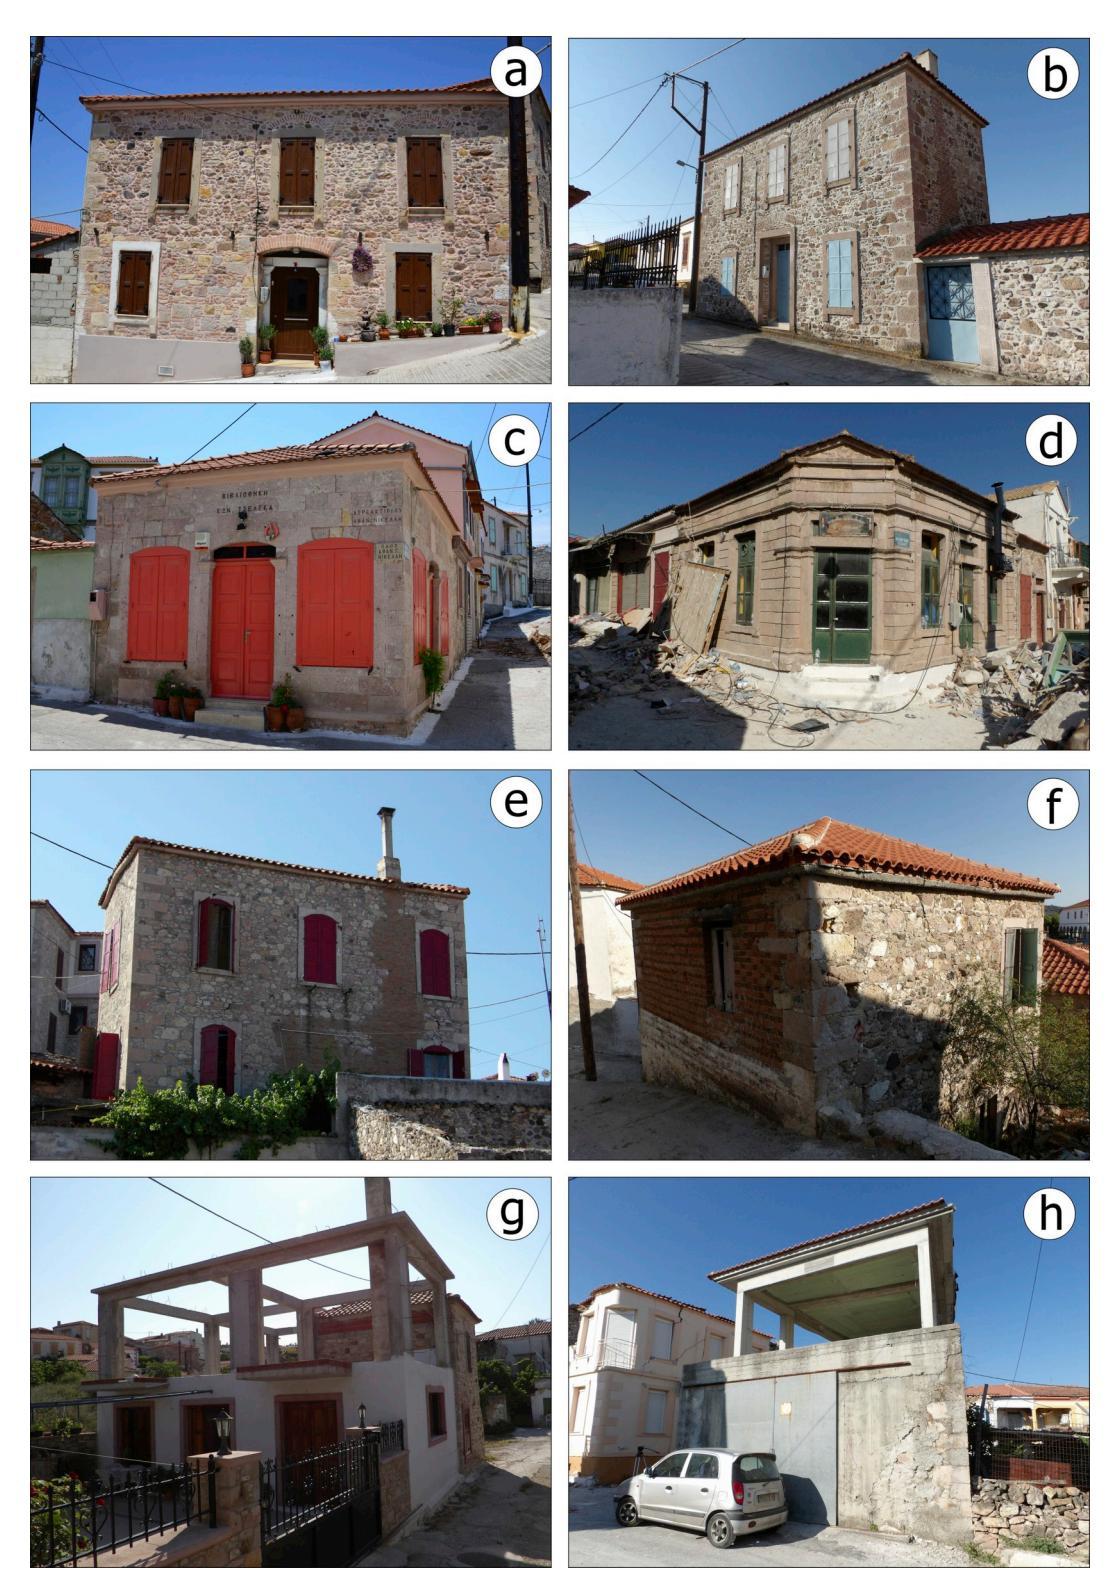
**Fig. 6.** The dominant building types in Vrissa comprise masonry buildings (a–f) and R/C buildings (g–h). The masonry buildings constitutes the majority of the building stock of Vrissa. They mainly include massive stones (a–d) and mixed types including mainly massive stones and perforated bricks (e, f). Their construction is dated back to the late 19th or early 20th century after repeated destructive earthquakes of the 18th century and more specifically from 1845 to 1889. The R/C buildings (g, h) comprise an R/C frame with infill and partition walls.

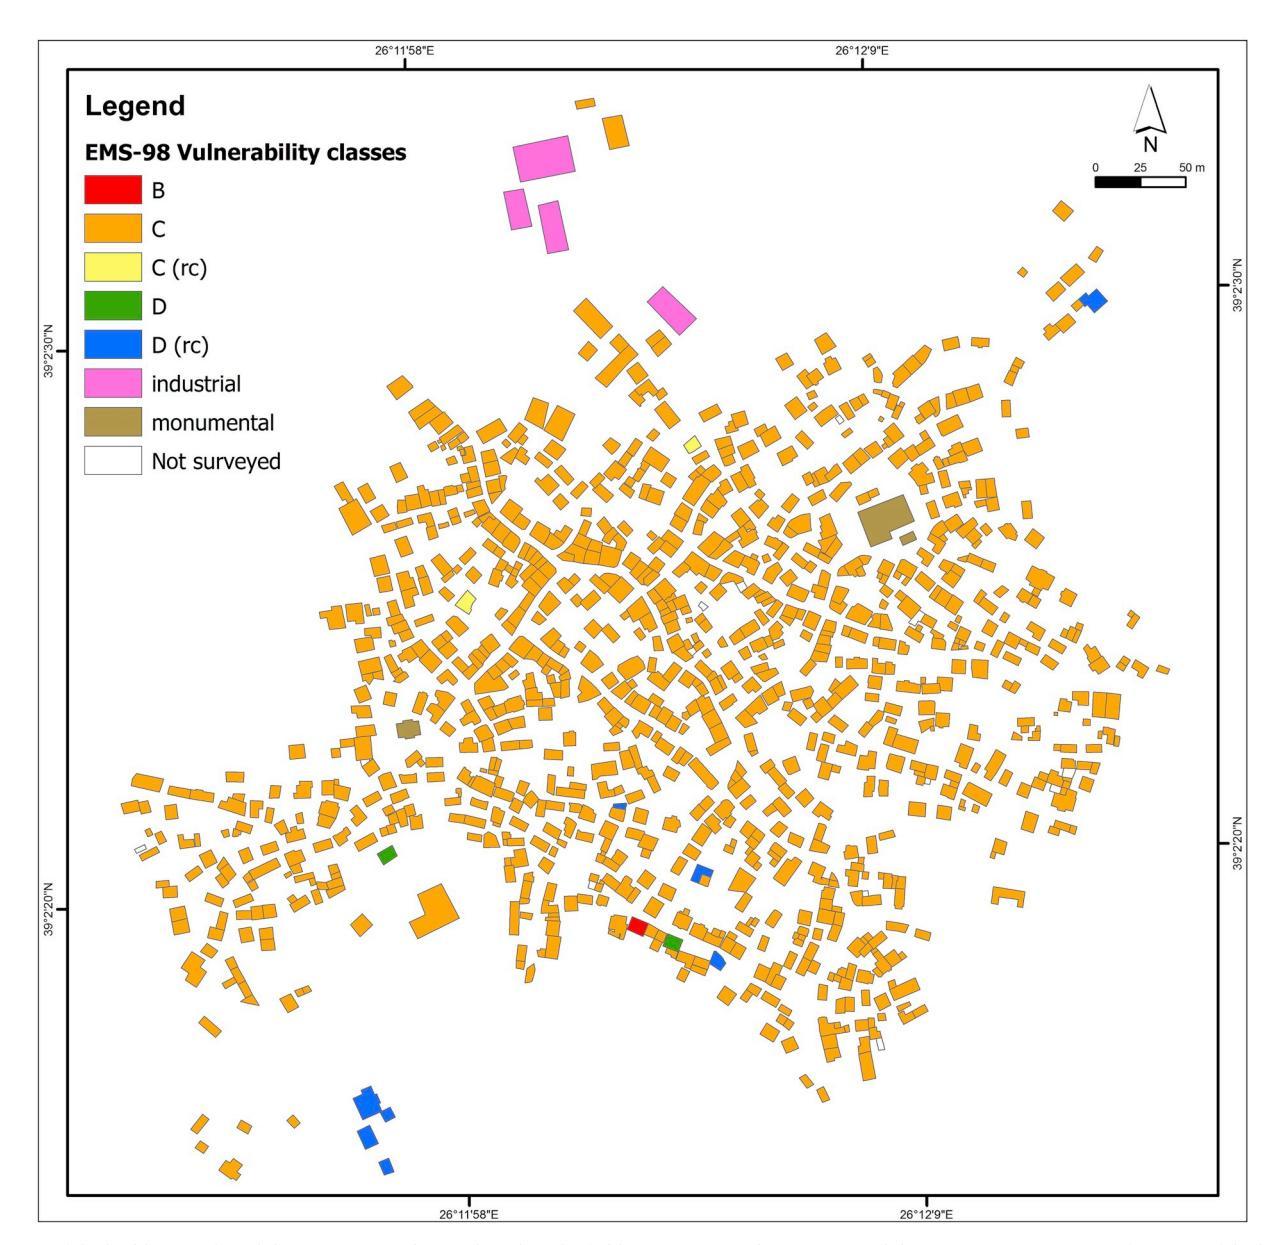
Fig. 8. Map of the buildings' vulnerability in Vrissa settlement based on the field macroseismic observations and the EMS-98. A percentage of 99.38% of the buildings are of vulnerability class C.

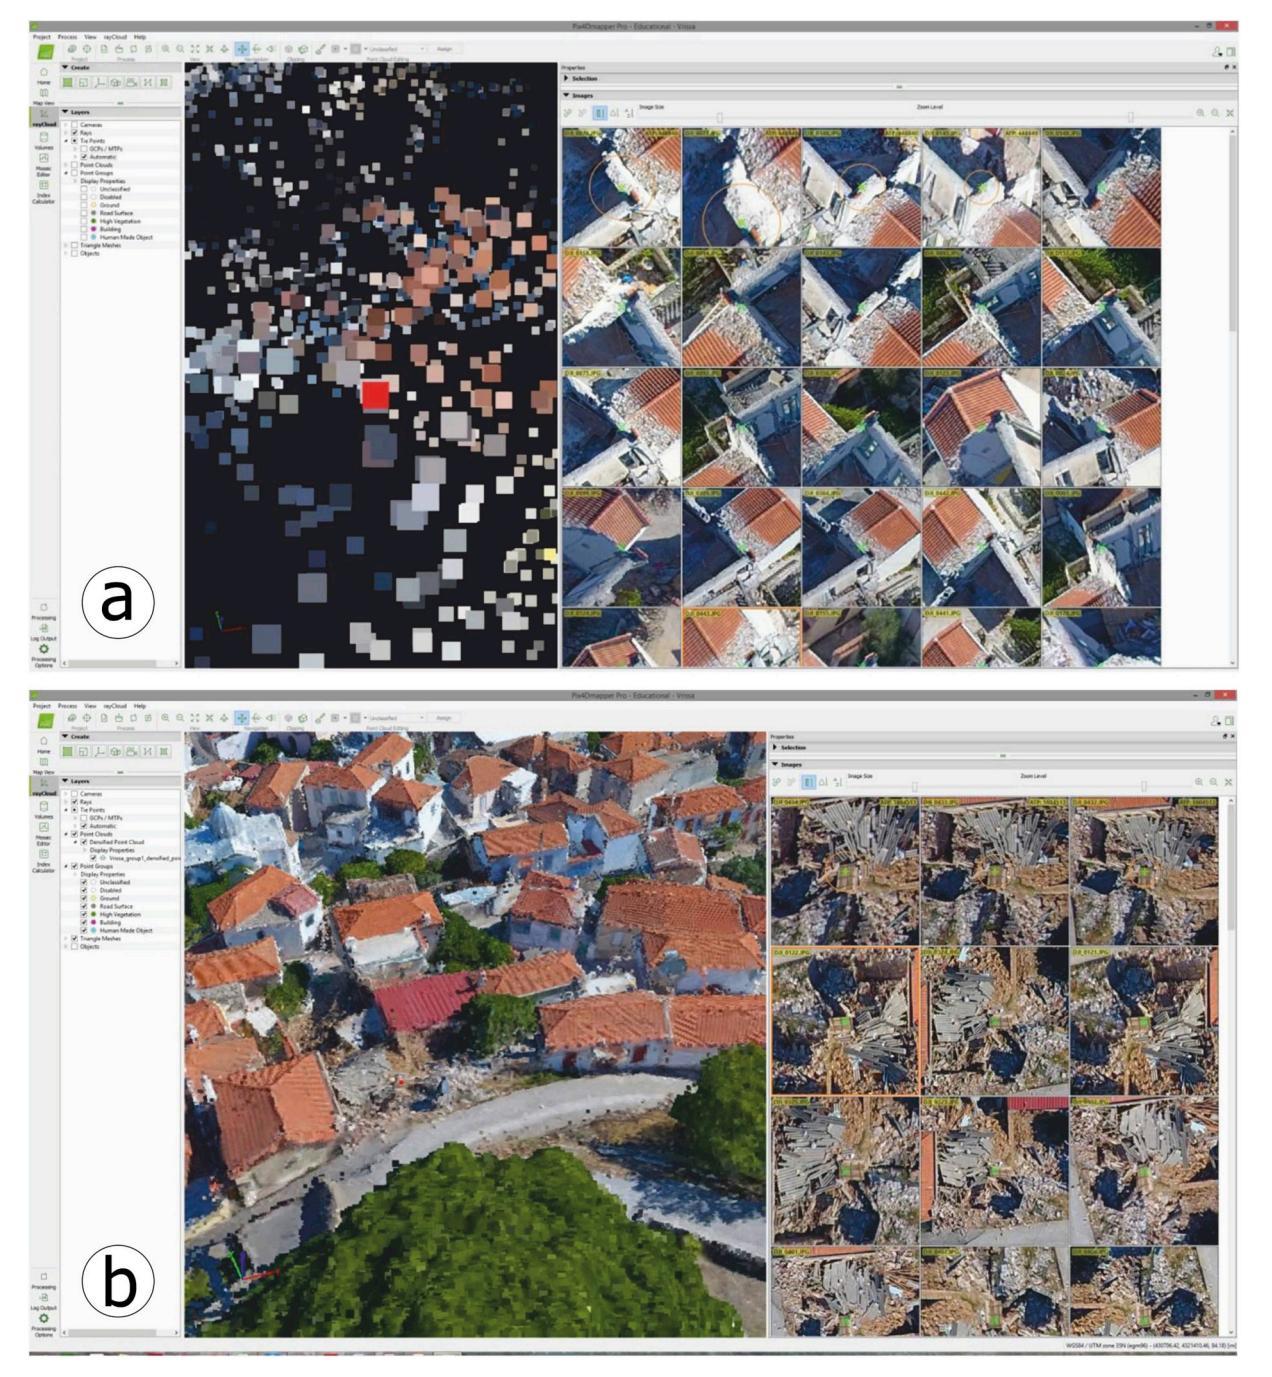
Fig. 12. Building inspection with multiple points of view through Pix4D environment.

The field observations including vulnerability classes, building damage and damage grades based on the EMS-98 application were verified for accuracy by revisiting the site through the acquired 3D model produced in previous step of the applied methodology and by using all footage available for any point on demand, in Pix4D (Fig. 12). All polygons were finally attributed with a unique number, a code description referring to the building type, a vulnerability class and a damage grade. A vulnerability map (Fig. 13a) and a damage grade map (Fig. 13b) were produced based on the buildings polygon and their attributes.
