Flooding in Athens: The Kephisos River flood event of 21-22/10/1994

Short description of the event

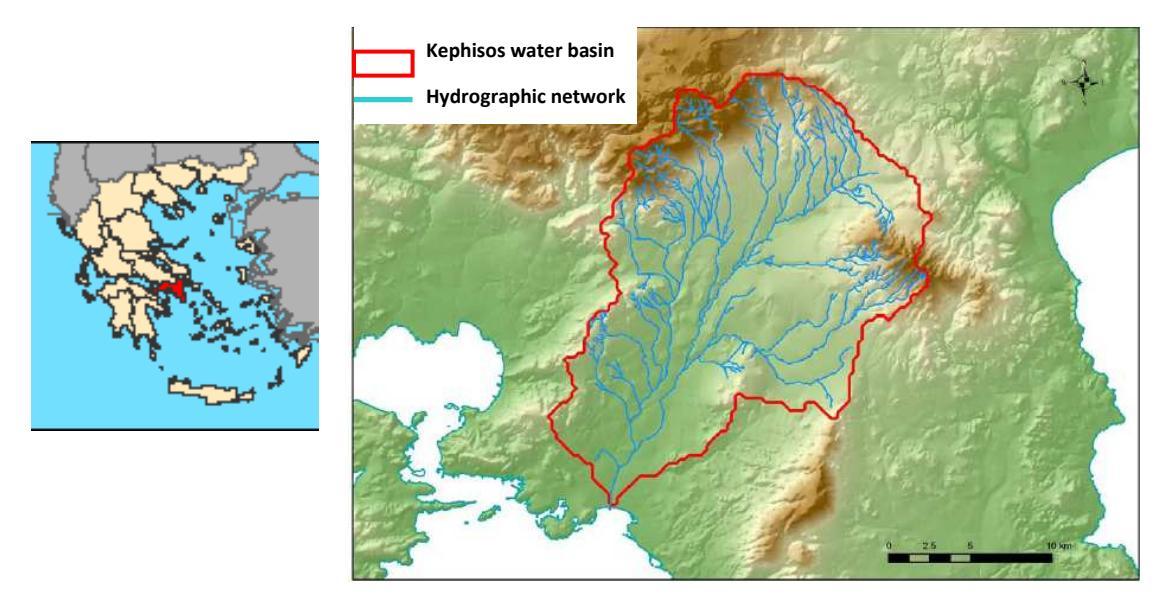
Fig.1: A schematic of the Kephisos River network

The Kephisos River (Figure 1) springs from Parnitha's mountain range, which is part of the National Forest and is included in the «Natura 2000» protected sites. The river, which is the major recipient of the Athenian rainfall runoff, covers an area of 381 km², while its length is 22 km (of which 14 km are within residential areas).

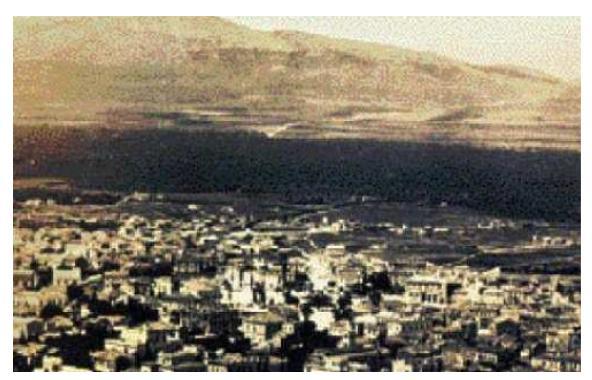
Fig.2: Western Athens (1870) (Source: Laskaris 2008)

The urbanization of western Attica, primarily by refugees and internal immigration, resulted in a socio-economic segregation of the population of Athens, which still evident, to some extent, even today. In Figures 2 and 3 the extensive urbanization that took place in the last 137 years around the river can be observed.

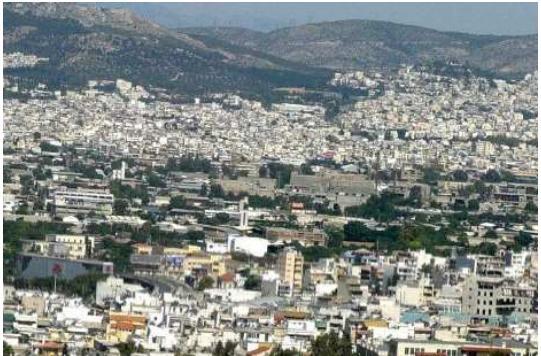
Fig.3: Western Athens (2007) (Source: Laskaris 2008)

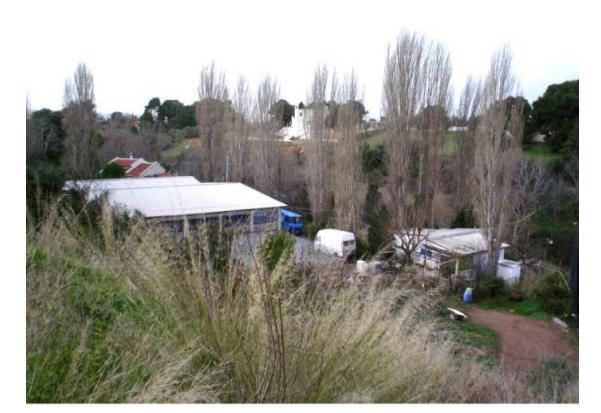
Fig. 4: Structures on river bed (Source: Laskaris 2008)

Currently, the urbanized area of the Kephisos river catchment amounts to 70% of its total extent; a number which is set to increase in the near future. In the following figures, typical examples of arbitrary and illegal construction activity are presented.

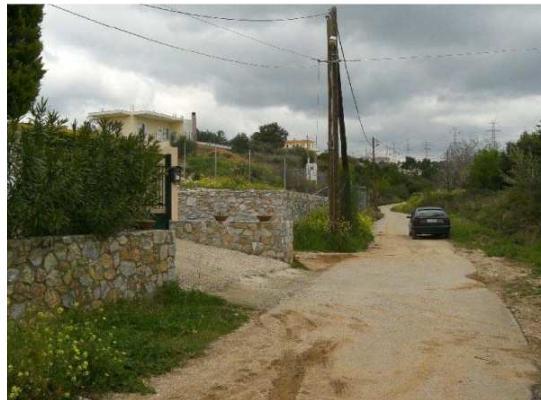
Fig.5: Roads and houses on streambeds (Source: Laskaris 2008)

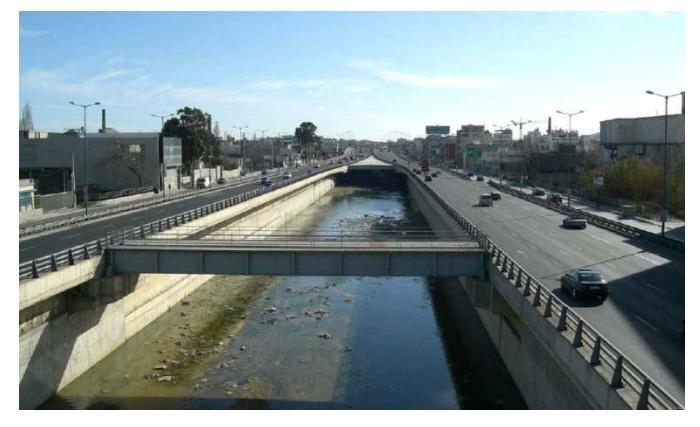
Fig.6: Combination of the drainage channel with Kephisos Avenue (Source: Laskaris 2008)

- The Kephisos river is successfully engineered from «Treis Gefures» to the «Faliro» Bay and no further interventions to increase discharge are needed
- From «Treis Gefures» to «Agia Anna», the river is covered and a highway is constructed on top of it (Figure 6).
- The river runs in an open channel cross-section from «Agia Anna» to to «Posidonos» Avenue and from there to the river estuary in the Saronikos Bay.
- From «Treis Gefures» upstream, the river is supposed to retain its open section profile, although the studies for the final engineering design have not yet been completed, while many parts of Kifissos still have serious problems with embankments along the river bed, arbitrary settlement activities and deposition of all kinds of solid and liquid waste.

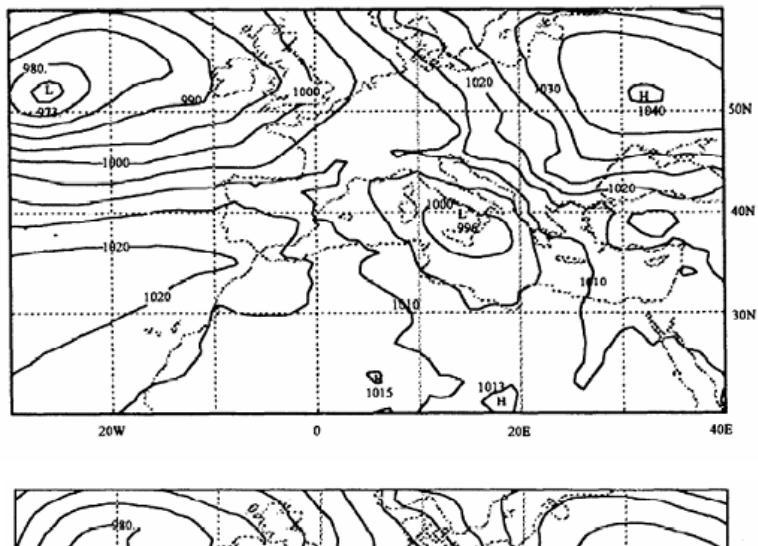
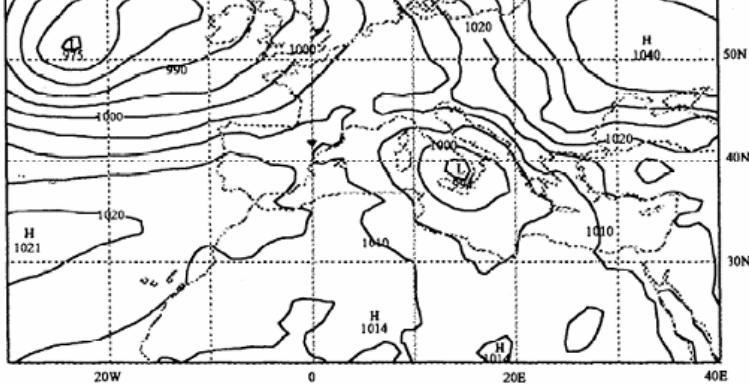
Fig.7: Surface pressure maps (5 hPa interval) in 21/10/1994 12:00 UTC (above) and 18:00 UTC (below) (Lagouvardos et al. 1996)

At 21/10/1994 00 UTC a low center (999 hPa) was situated over the Golf of Genoa. The cyclonic propagated eastward and 12 hours later was deepened (996 hPa) and moved over southern Italy (Figure 7). At 21/10/1994 18 UTC the low center was further deepened (994 hPa) while a cold front associated with the low center progressed toward the Ionian Sea. During October 21-22, 1994 the cold front passed over Greece and provoked extreme precipitation in several regions. In Figure 8, the geographical distribution of 24 h precipitation (from 21/10/1994 06 UTC to 22/10/1994 06 UTC) in Greece, as measured by rain gauges, is presented. Extreme rainfall occurred mainly in the mountainous western Greece (with daily value about 150 mm) and in the Attica region where the city of Athens is located. More detailed presentation of the event is given in Figure 9, where geographical distribution of hourly precipitation in several rain recorders installed in Athens, is presented. It can be observed that the stations located in the Kephisos river basin present analogous rainfall evolution and the rainfall's peak occurs at the time interval between 18:00-20:00 of the 21/10/1994.

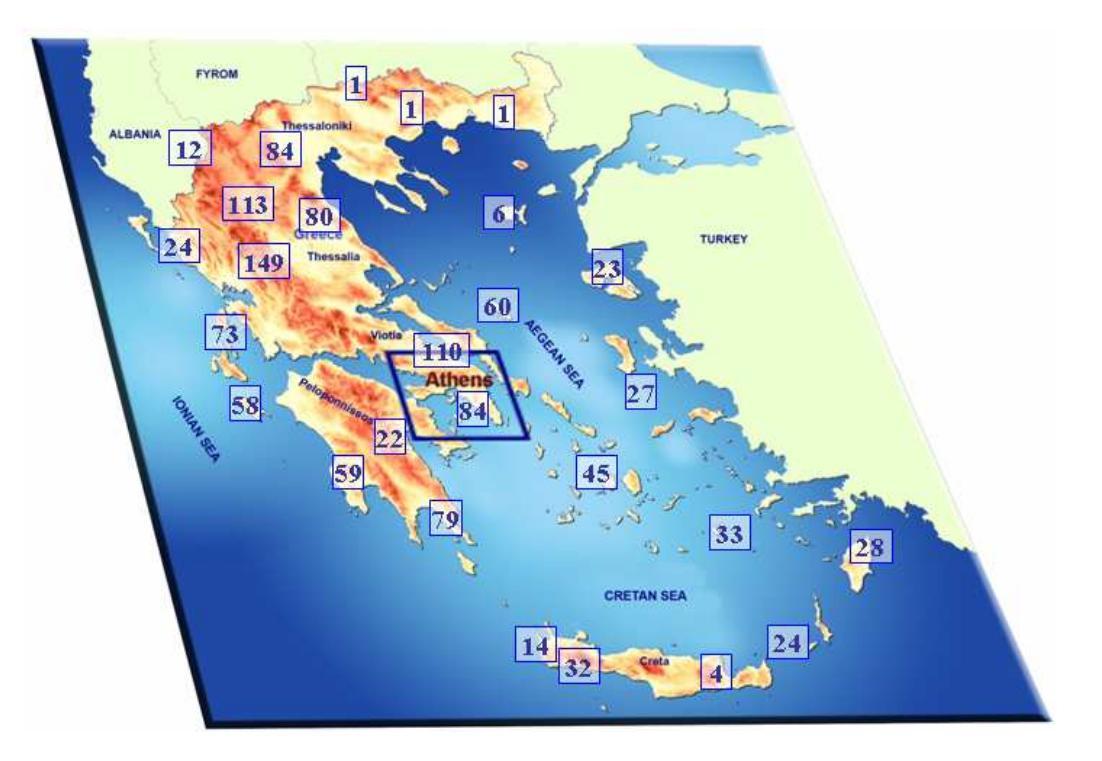
Fig.8: Geographical distribution of 24 h precipitation in Greece (from 21/10/1994 06 UTC to 22/10/1994 06 UTC)

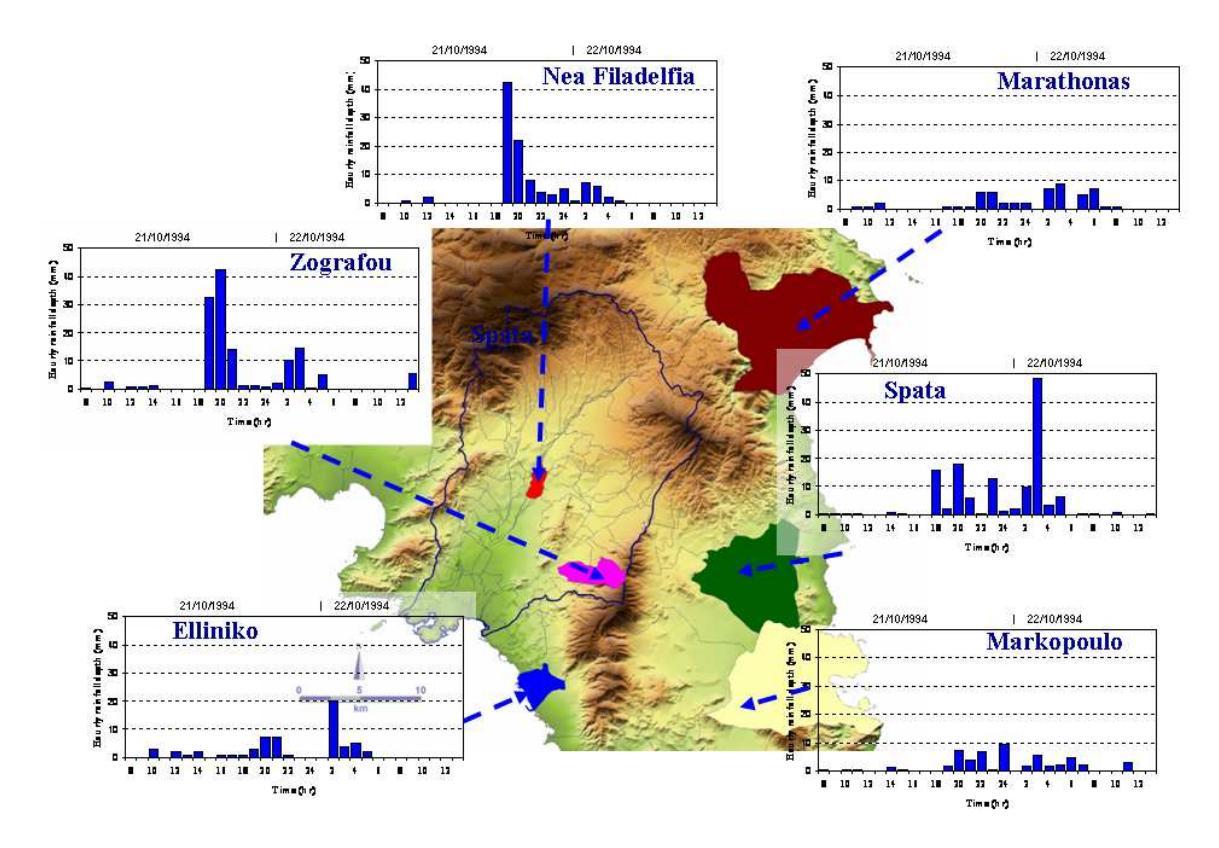
Fig.9: Geographical distribution of hourly precipitation in Athens area

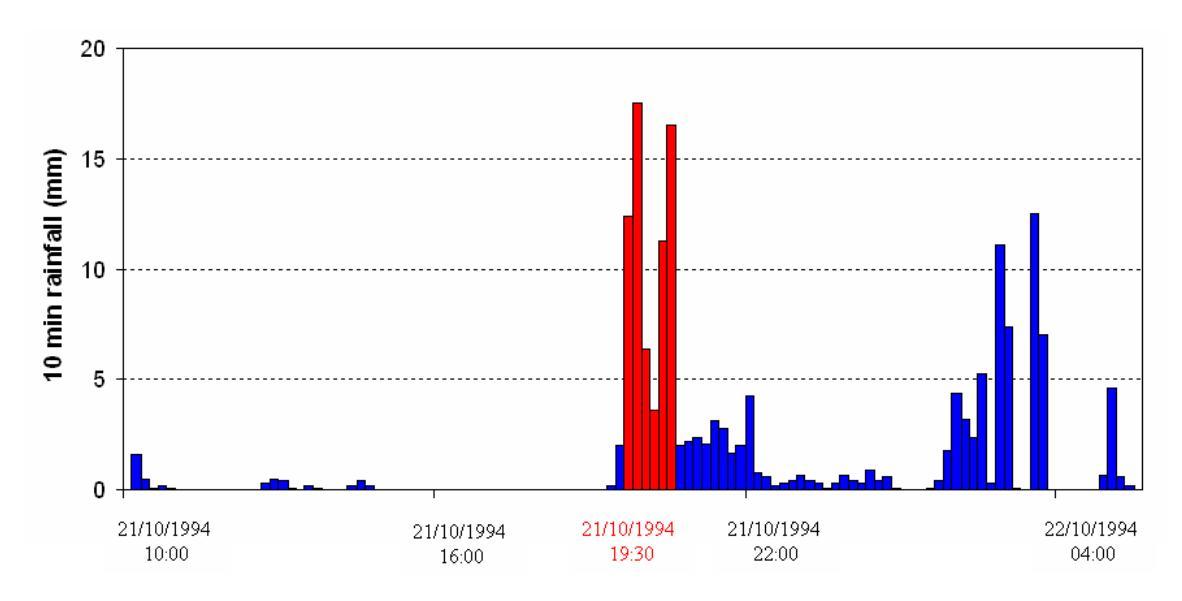
Fig. 10: 10 minutes hyetograph of 21-22/10/1994 in NTUA Campus station

Rainfall measurements of the specific event, with a time step of 10 minutes are available from the automatic telemetric meteorological station that is located in the NTUA University Campus in the Zographou area. In Figure 10, the 10 minute hyetograph of 21-22/10/1994, as measured at NTUA station, is presented. The maximum rainfall height was 17.5 mm and was observed at 19:40 of 21/10/1994. The maximum hourly rainfall height was 67.7 mm and was observed at the time interval between 19:30-20:30 of 21/10/1994.

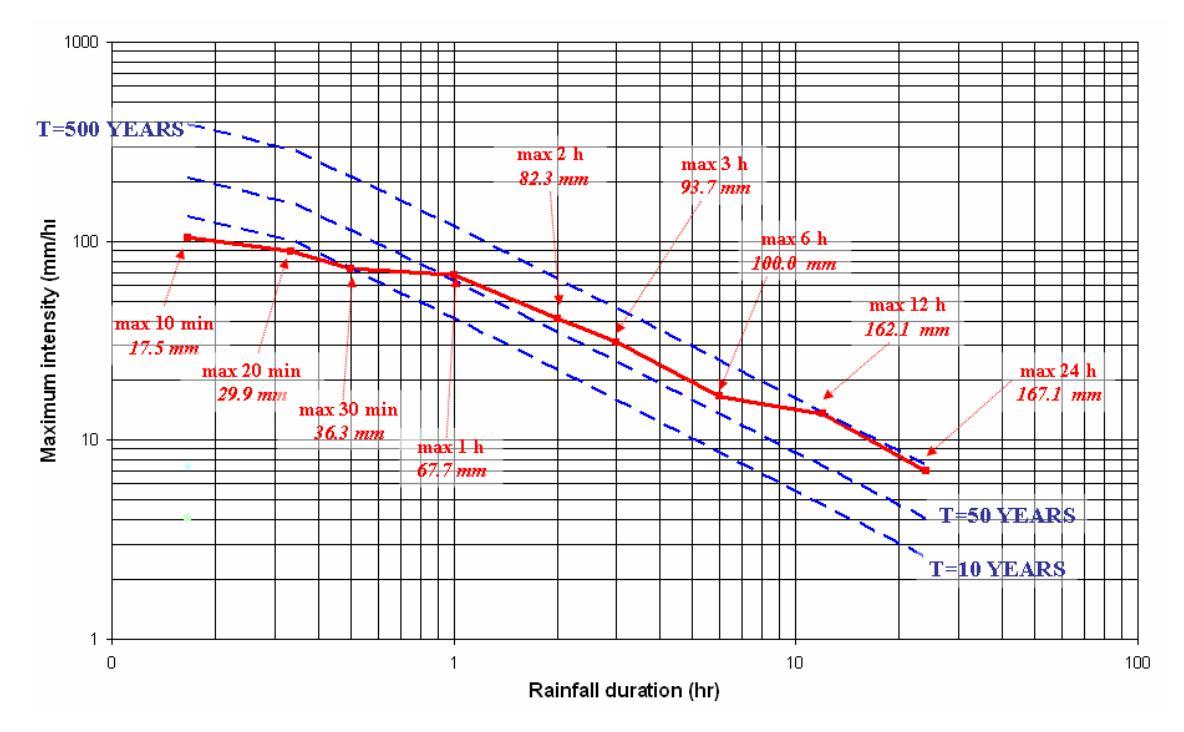
Fig.11: Frequency analysis of the storm as measured in NTUA station

In order to define the return period of the event, a frequency analysis of the storm was performed as presented in Figure 11. The event has also been studied by Mimikou and Koutsoyiannis (1995). The red curve includes the maximum rainfall intensities observed within the rainfall event for several durations (10 min, 20 min, 30 min, 1h, 2h, 6h, 12 h and 24 h). The curve is compared with the Intensity-Duration-Frequency (IDF) curves of Athens for return periods 10, 50 and 500 years. During the event evolution (21-22/10/1994) unusual high rainfall intensities (exceeding the 50 years return period) for durations greater than 1 hour, were observed. On the other hand, within the same event there were no significant rainfall intensities for 10, 20 and 30 minutes durations. The return period for these durations was estimated at approximately 10 years.

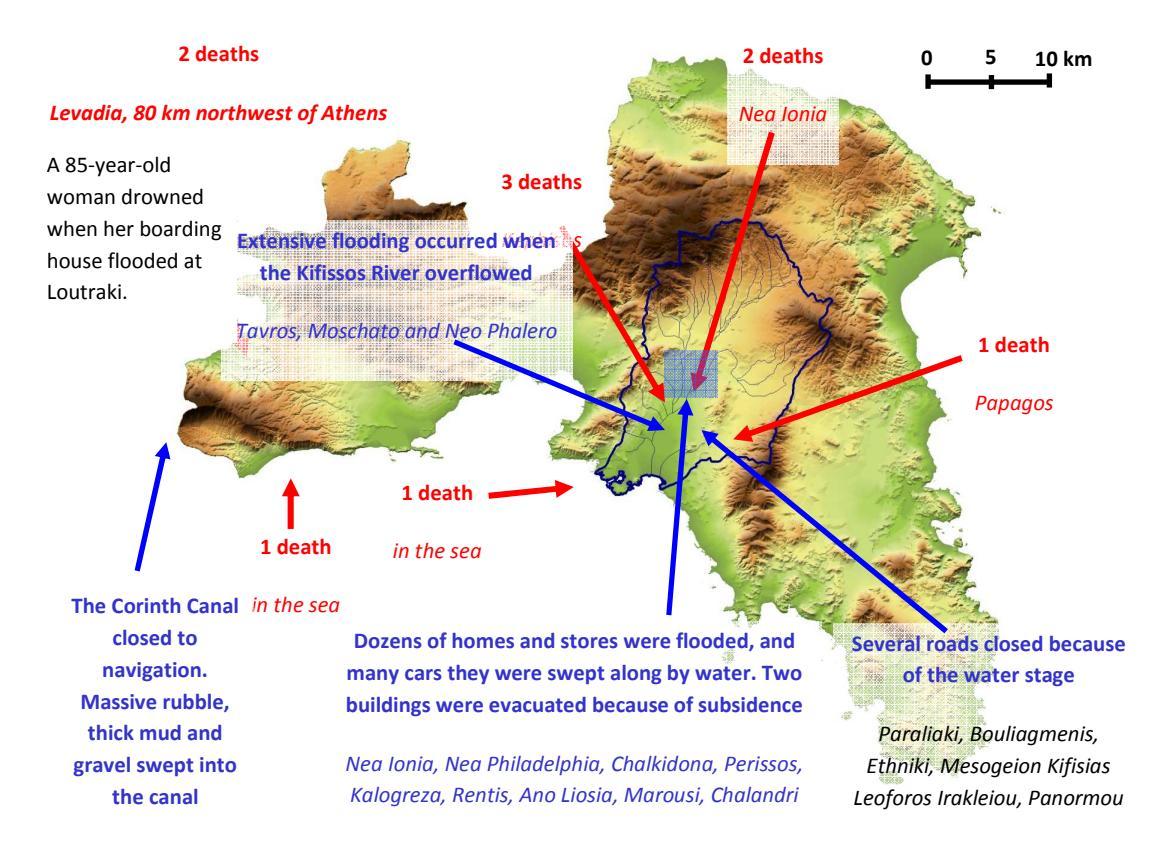
Fig.12: Geographical distribution of casualties and damages

In Figure 12 the geographical distribution of casualties and damages is presented. Eleven deaths were reported, while nine of them occurred in the greater Athens area.
